# Polyisoprene Lining for Vacuum Pump Reconditioning

**A reliable and cost effective solution for pumps used in corrosive and erosive processes.**

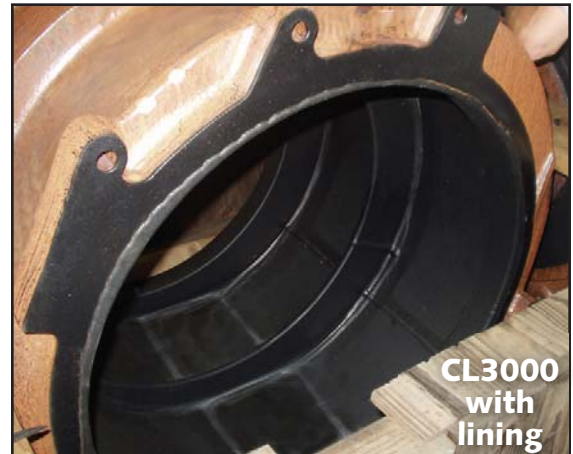
**Polyisoprene lined casing - before use**

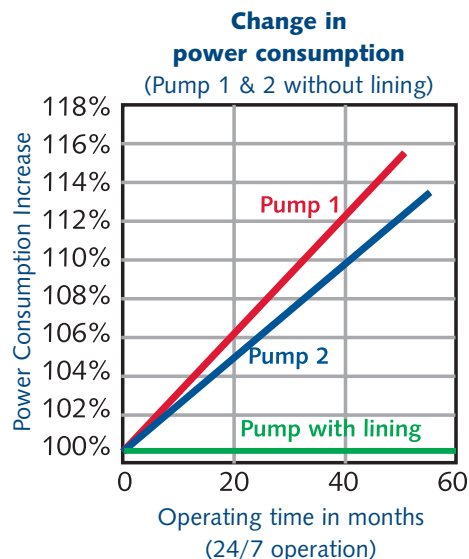
The graph at right is based on actual field measurements. It illustrates the power consumption increase of two vacuum pumps with standard unlined casings, over a period of about 50 months, in a paper mill with a closed water system. Absorbed power was in the range of 114 to 116 percent and still rising.

The casing of a liquid ring vacuum pump is especially prone to this type of wear, because it is in contact with the liquid seal. Typically, after prolonged exposure to these corrosive and erosive elements, the surface of the casing becomes rough, which increases the friction factor. This results in an increase in the amount of energy required to rotate the liquid ring. Nash has measured power consumption increases of up to 20 percent under these circumstances.
